- Test Agency ..... CSI Certificazione e Testing
- Test Number ..... 0068\ME\HRB\15
- Reference Standard
  - UNI EN 1317-1:2010
  - UNI EN 1317-2:2010
- **ITT** ..... **TB11**
- Date ..... 01/09/2015
- **Test Article** ..... **Dispositivo de Contensão Nível N2**
- Total Length ..... 72,0 m
- Key Elements - Barrier
  - Description: N2 Class Monolateral barrier for installation on soil
  - Length: 4,0 m
  - Width: 211,0 mm
  - Height: 724,5 mm
- Test Vehicle
  - Type/Designation ..... 900C
  - Make and Model..... 1996 Peugeot 106
- Impact Conditions
  - Speed ..... 101,00 km/h
  - Angle ..... 20 °
  - Location/Orientation ..... Poste 07
- Post-impact Trajectory
  - Vehicle Stability ..... Satisfactory
  - Vehicle remains within the exit box ..... Yes

- Test Agency ..... CSI Certificazione e Testing
- Test Number ..... 0067\ME\HRB\15
- Reference Standard
  - UNI EN 1317-1:2010
  - UNI EN 1317-2:2010
- **ITT ..... TB32**

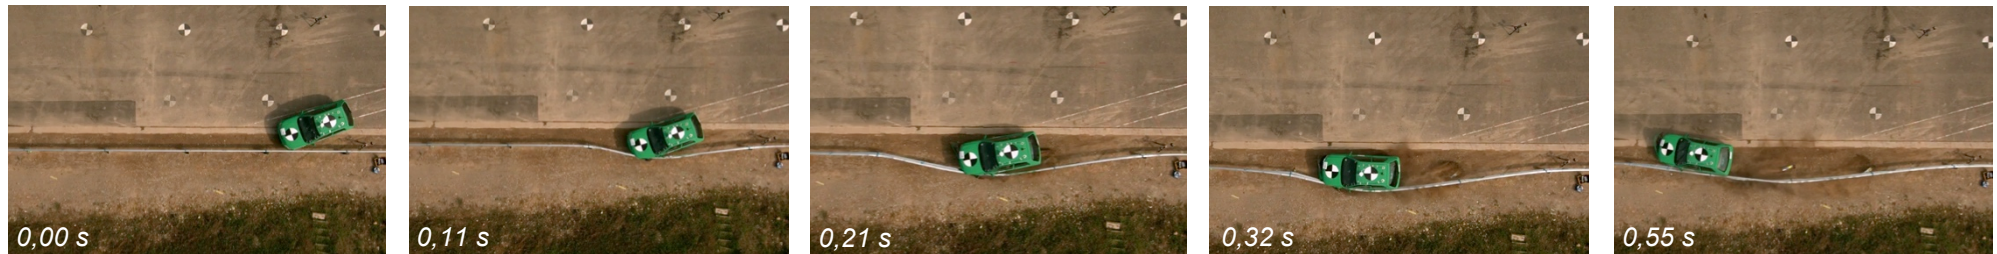
- Vehicle Snagging ..... No
- Vehicle Pocketing ..... No
- Vehicle rolls over ..... No
- During and after the impact no more than one wheel of the vehicle steps over the rearmost part of the deformed system ..... Yes
- VCDI ..... 0000000
- Impact test acceptance criteria
  - ASI ..... 0,56
  - Flight time ..... 169,00 ms
  - THIV ..... 24,79 km/h
  - **Severity level** ..... **A**
- Test Article Deflections
  - Permanent Set ..... 0,81 m
  - Dynamic ..... 0,90 m
  - Working Width ..... 1,20 m
  - **Functional level** ..... **W4**
- Test Acceptance Criteria
  - **The barrier contains the vehicle** ..... **Yes**
  - Complete breakage of any principal longitudinal elements ..... No
  - Parts over the mass of 2kg detached ..... No
  - Penetration of elements into the passenger compartment ..... No
  - Deformation of elements into the passenger compartment ..... No

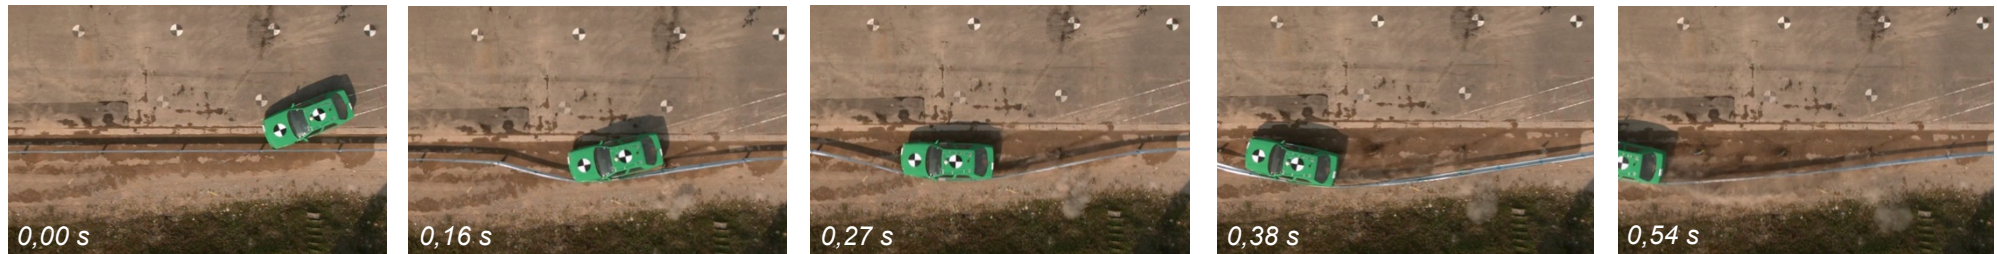
- Date ..... 01/09/2015
- **Test Article ..... Dispositivo de Contensão Nível N2**
- Total Length ..... 72,0 m
- Key Elements - Barrier
  - Description: N2 Class Monolateral barrier for installation on soil

- Length: 4,0 m
  - Width: 211,0 mm
  - Height: 724,5 mm
- Test Vehicle
  - Type/Designation ..... 1500A
  - Make and Model..... 1992 Fiat Croma
- Impact Conditions

- Speed ..... 112,10 km/h
  - Angle ..... 20,5 °
  - Location/Orientation ..... Poste 07
- Post-impact Trajectory
  - Vehicle Stability ..... Satisfactory

- Vehicle remains within the exit box ..... Yes
- Vehicle Snagging ..... No
- Vehicle Pocketing ..... No
- Vehicle rolls over ..... No
- During and after the impact no more than one wheel of the vehicle steps over the rearmost part of the deformed system ..... Yes

- Test Article Deflections
  - Permanent Set ..... 1,24 m
  - Dynamic ..... 1,90 m
  - Working Width ..... 2,00 m
  - **Functional level ..... W6**
  - Vehicle Intrusion ..... 0,00 m

- Length of contact ..... 21,00 m
- Test Acceptance Criteria
  - **The barrier contains the vehicle ..... Yes**
  - Complete breakage of any principal longitudinal elements ..... No

- Parts over the mass of 2kg detached ..... No
  - Penetration of elements into the passenger compartment ..... No
  - Deformation of elements into the passenger compartment ..... No
